# **LakeSPI Assessment of 15 Auckland Lakes: 2021/2022**

M D de Winton, S R Elcock, A T Taumoepeau. NIWA

Technical Report 2022/21

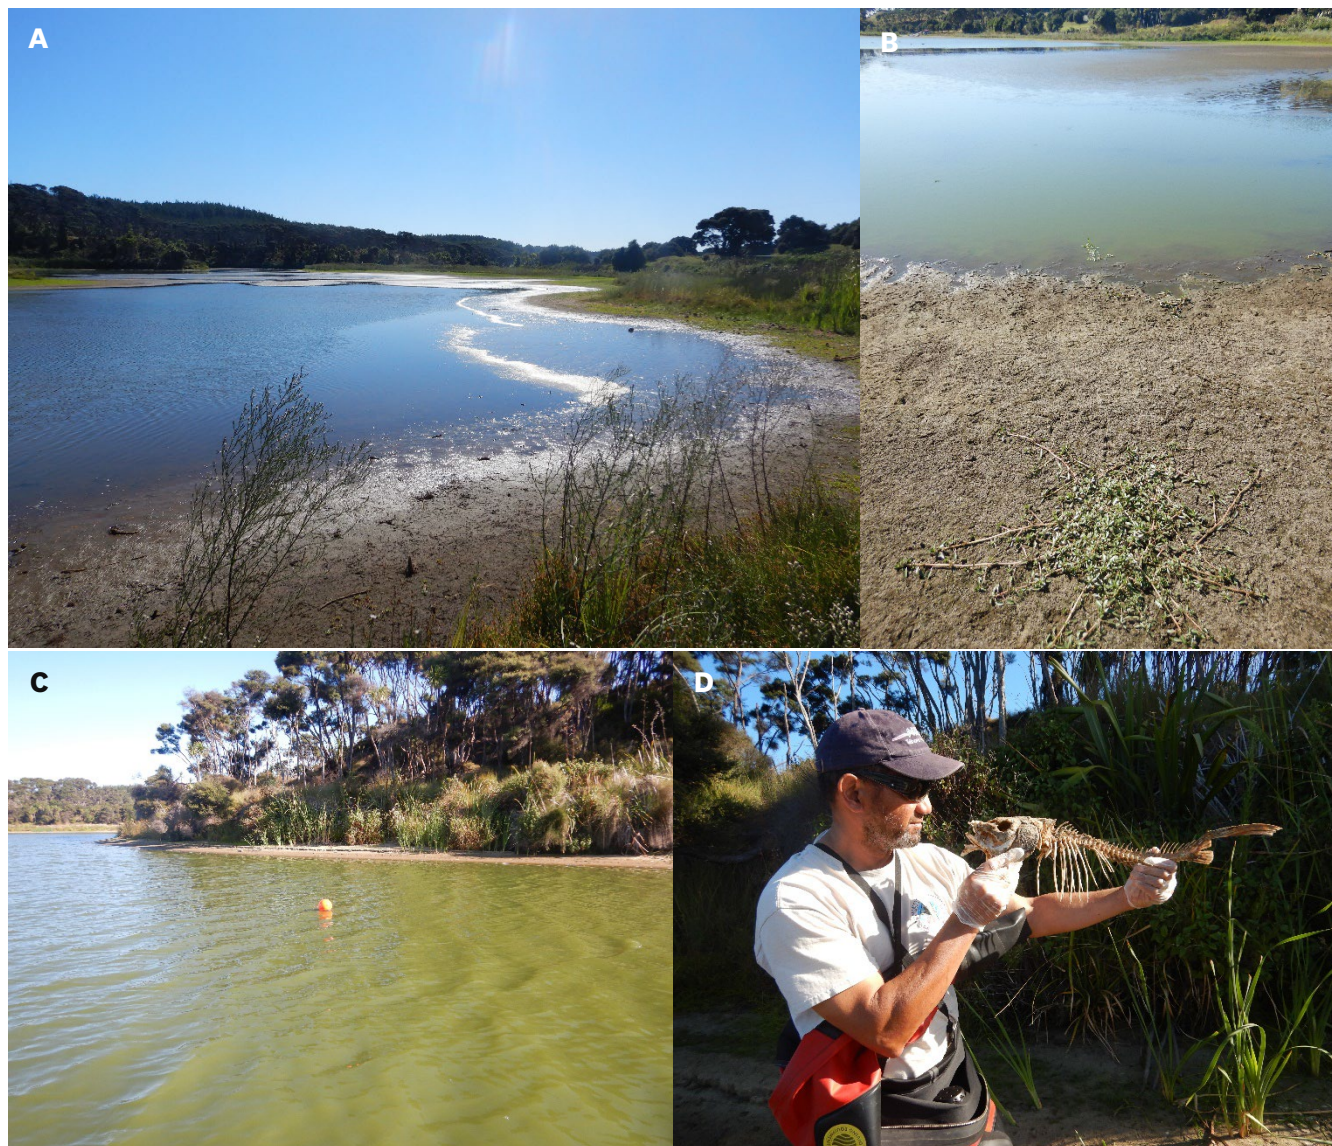
*Figure 15 – Water level of Lake Kereta A) and B) was extremely low at the time of NIWA’s survey, C) an algal bloom was noted and D) a number of grass carp frames were exposed at the margin of the lake.*

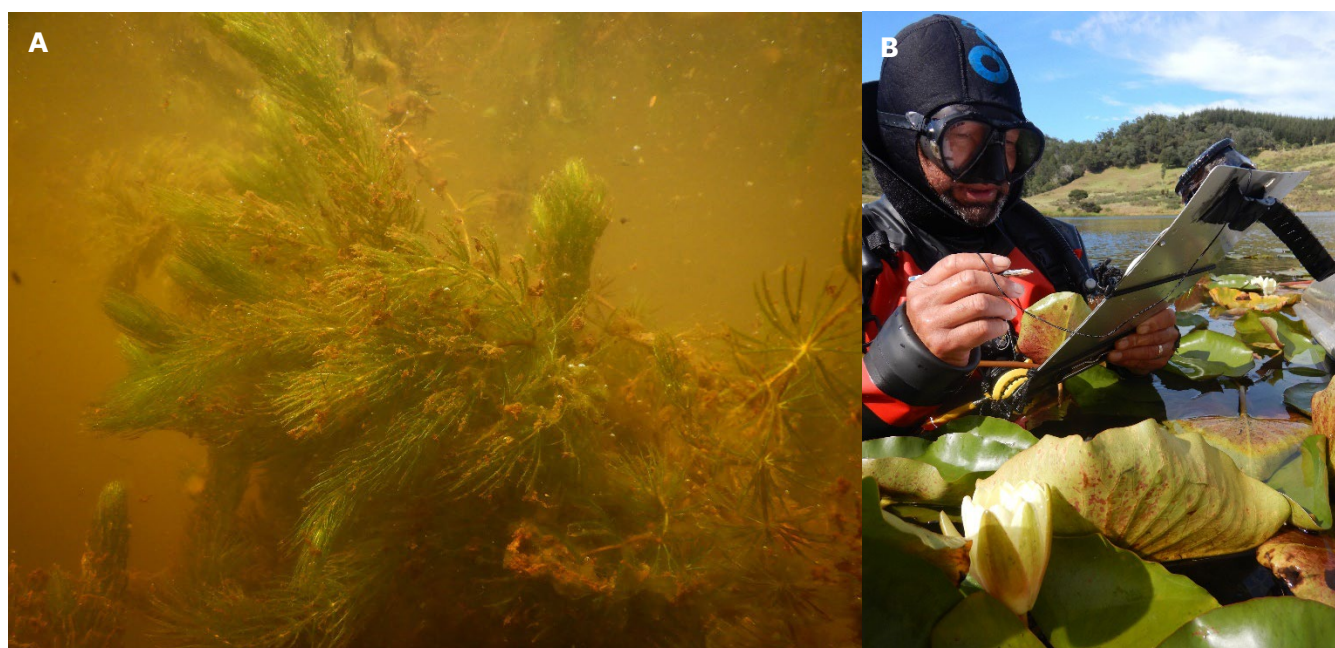
Figure 17 – Dominant vegetation in Lake Okaihou in 2022 included A) hornwort (*Ceratophyllum demersum*), and B) waterlilies (*Nymphaea cultivars*).

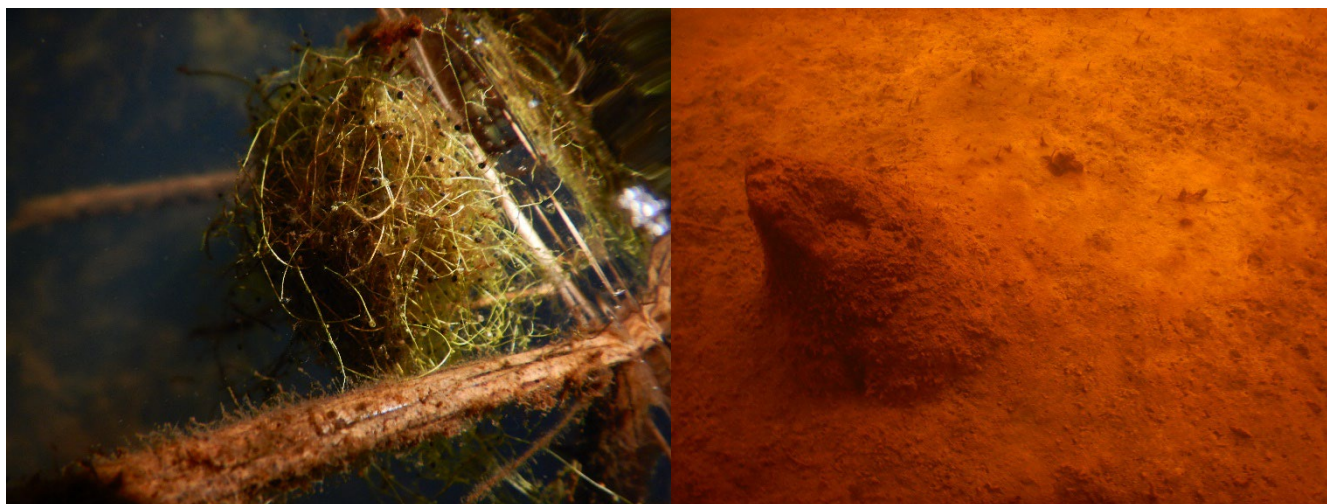
Figure 21 – Lake Wainamu had A) scattered clumps of invasive bladderwort (*Utricularia gibba*) amongst beds of emergents at the margin, but most of the lake bed B) was devoid of submerged plants.

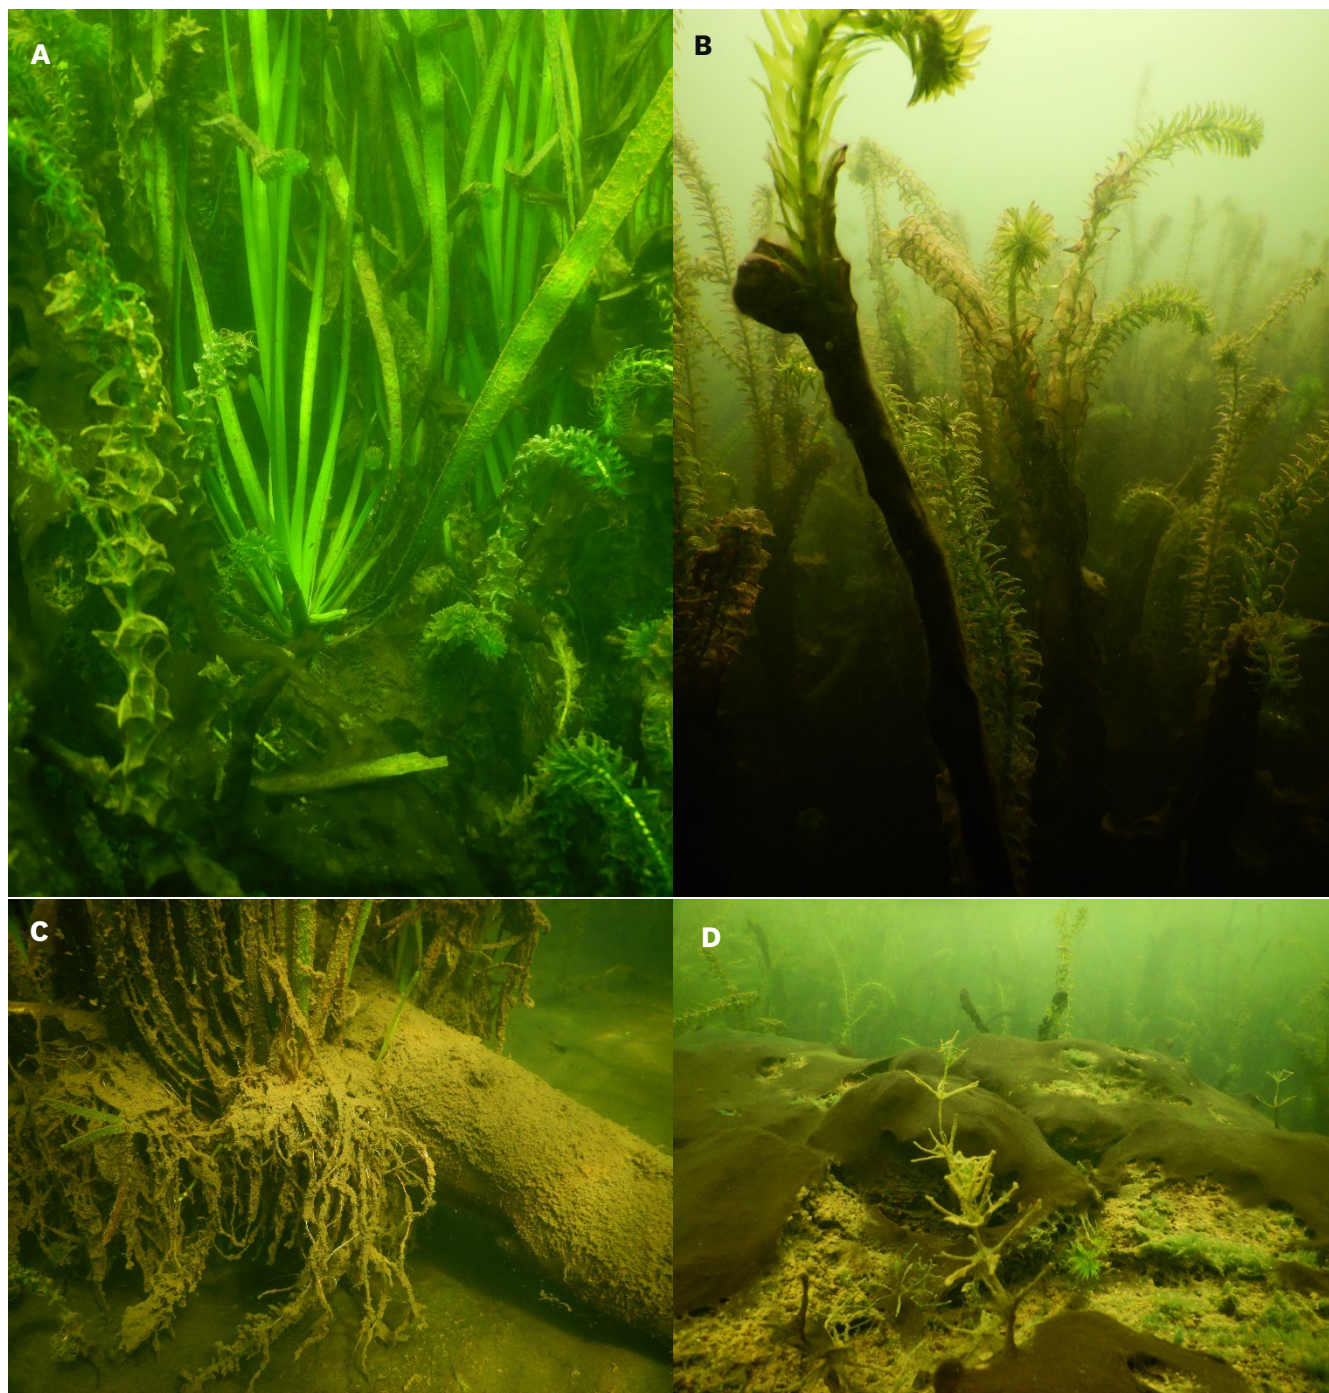
Figure 23 – Submerged vegetation at Lake Pupuke comprised A) eelgrass (*Vallisneria australis*) and egeria (*Egeria densa*), with B) egeria dominating in deeper water. Eelgrass root mats C) had commonly ‘lifted off’ the substrate. Remnants of the previous charophyte meadows D) could be seen at the deepest vegetation extent at two sites.

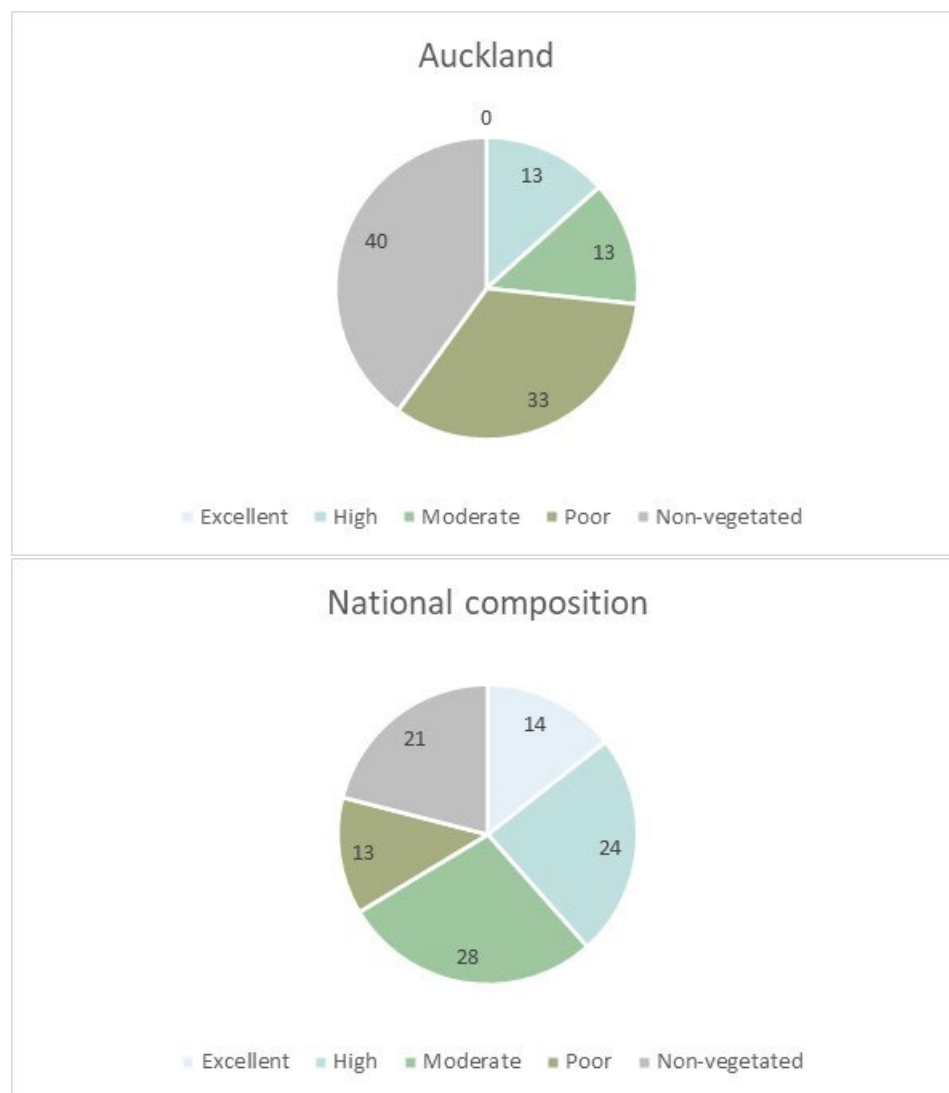
Figure 33 – Proportion of lakes that fall into each of five categories of LakeSPI Index for the Auckland region (15 surveyed lakes) and nationally (333 lakes), with percentage of lakes assessed shown for each category.

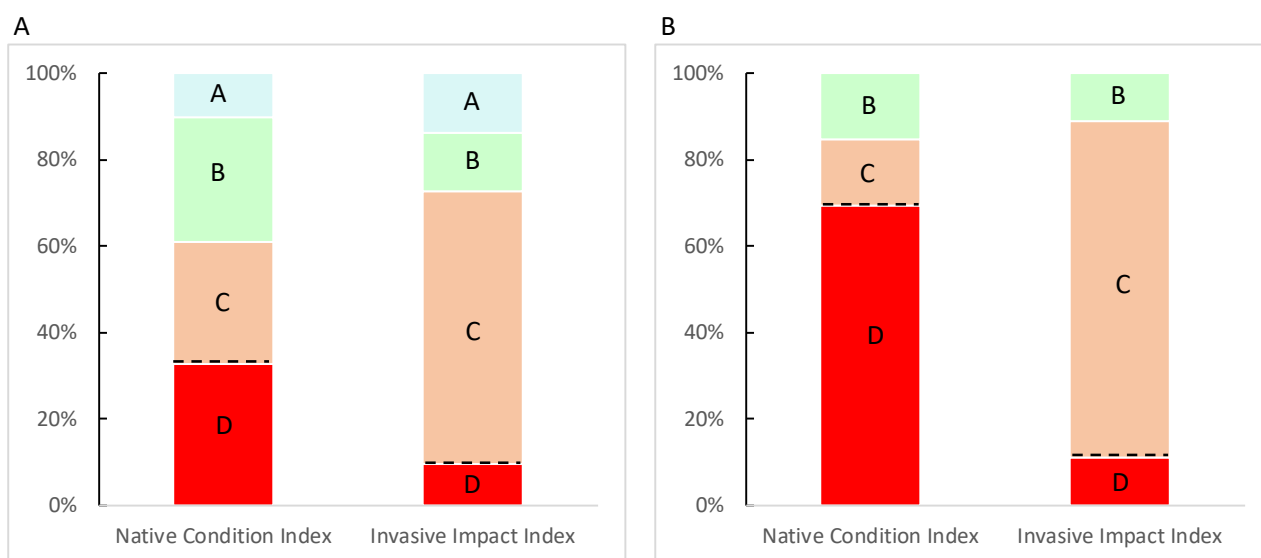
Figure 34 – Proportion of lakes in each attribute band for Native Condition Index and Invasive Impact Index, A) nationally and B) for Auckland Region. The black dotted line indicates the national bottom line. Number of assessed lakes for Native Condition Index is 333 nationally and 13 for Auckland region (grass carp stocked lakes excluded). Number of assessed lakes for Invasive Impact Index is 263 nationally and 9 for Auckland region (non-vegetated lakes excluded).

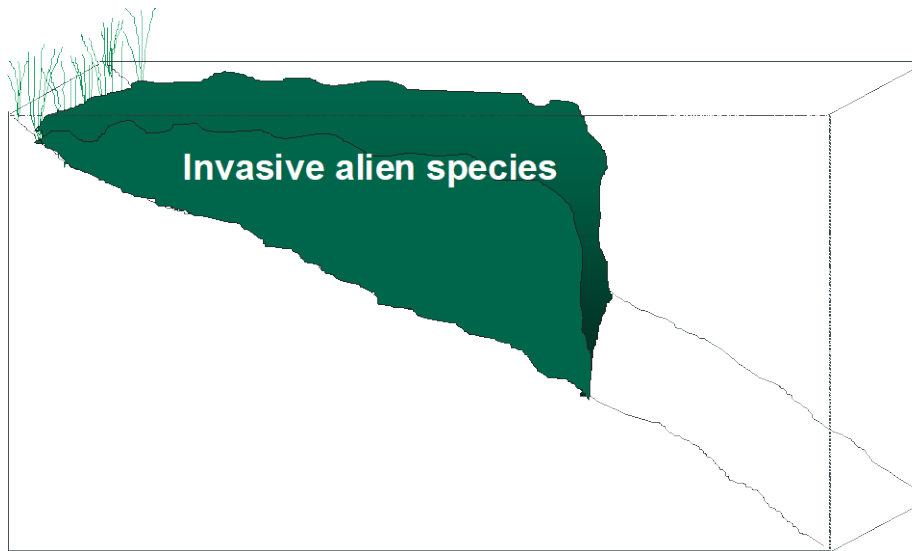
Figure 36 – Depth profile illustrating the potential impact of invasive species.

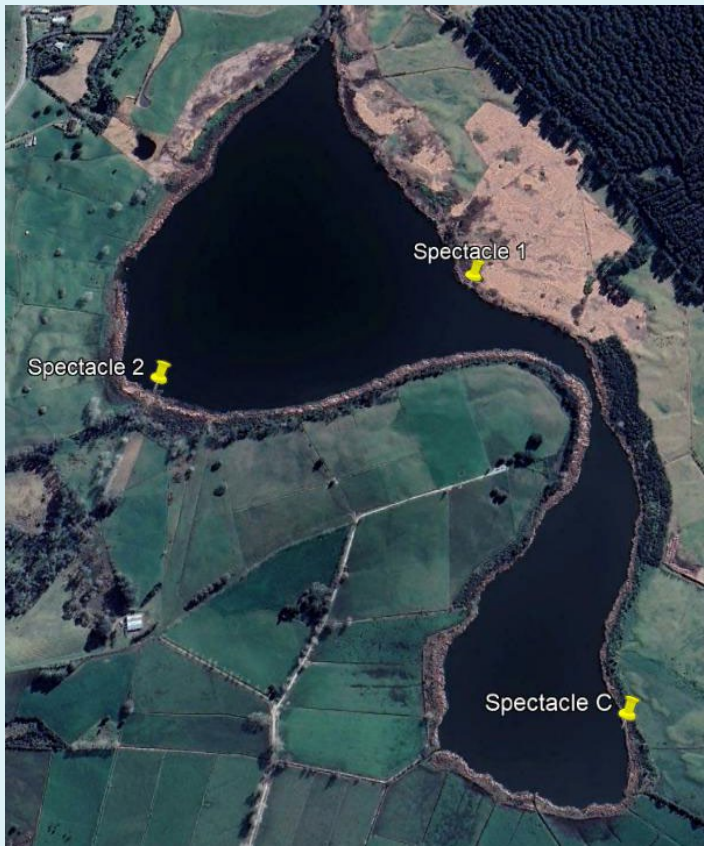
Slipper map	Lake and site	Northing	Easting

Spectacle A	36 10.812	174 37.999
	Spectacle B	36 10.912	174 37.655
	Spectacle C	36 11.216	174 38.200

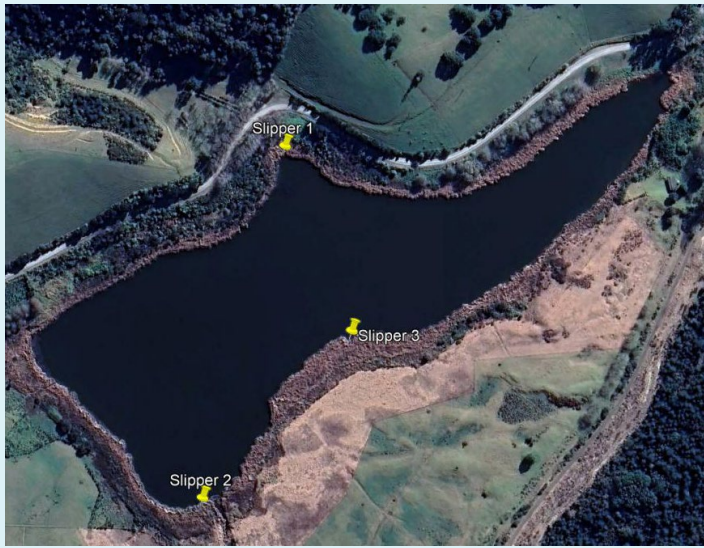
Slipper A	36 10.256	174 37.817
	Slipper B	36 10.435	174 37.765
	Slipper C	36 10.350	174 37.859
Rototoa map	Lake and site	Northing	Easting

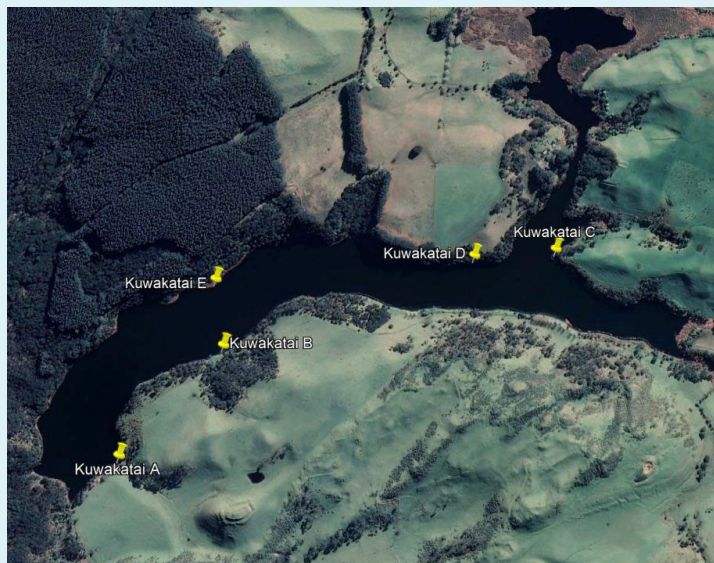
Kuwakatai map		Lake and site	Northing	Easting

Kuwakatai A	36 31.904	174 14.021
		Kuwakatai B	36 31.768	174 14.158
		Kuwakatai C	36 31.646	174 14.656
		Kuwakatai D	36 31.651	174 14.531
		Kuwakatai E	36 31.683	174 14.136
Te Kanae map		Lake and site	Northing	Easting

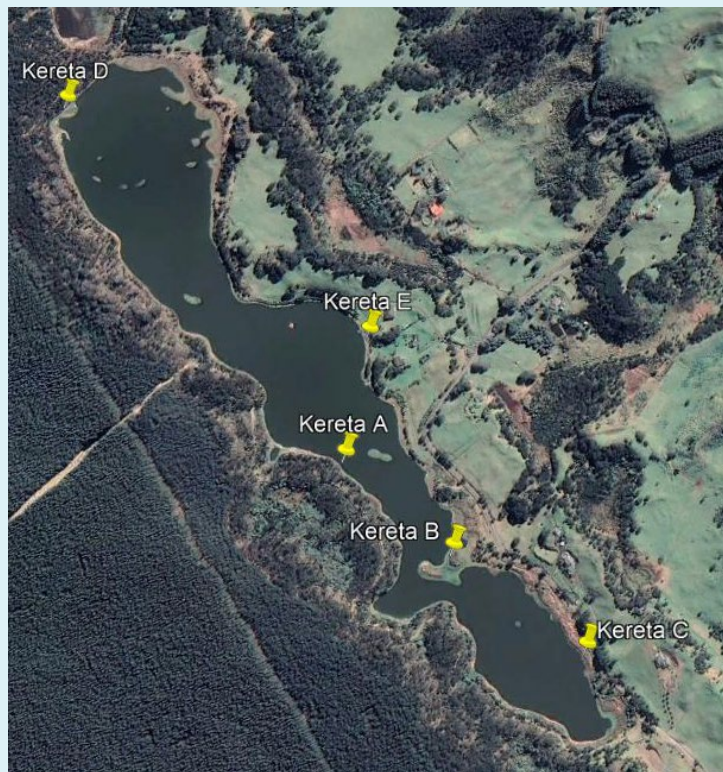
Kereta map		Lake and site	Northing	Easting

Kereta A	36 35.670	174 16.908	
		Kereta B	36 35.769	174 17.040	
		Kereta C	36 35.875	174 17.223	
		Kereta D	36 35.290	174 16.506	
		Kereta E	36 35.545	174 16.923

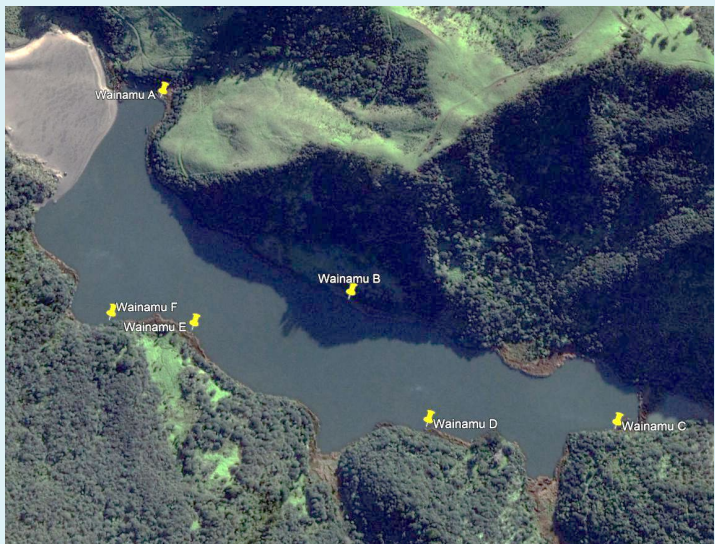
Wainamu A	36 53.208	174 27.981
	Wainamu B	36 53.375	174 28.179
	Wainamu C	36 53.473	174 28.438
	Wainamu D	36 53.475	174 28.257
	Wainamu E	36 53.398	174 28.024

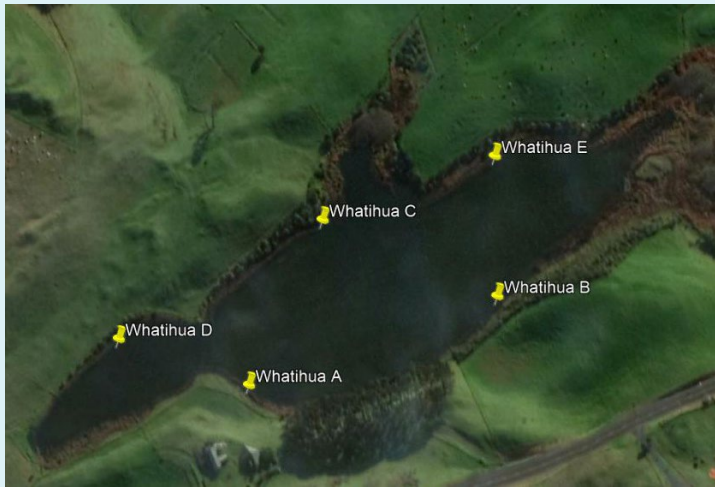
Whatihua map	Lake and site	Northing	Easting

Whatihua A	37 16.562	174 40.162
	Whatihua B	37 16.528	174 40.276
	Whatihua C	37 16.502	174 40.194
	Whatihua D	37 16.544	174 40.100
	Whatihua E	37 16.476	174 40.275
Pehiakura map	Lake and site	Northing	Easting

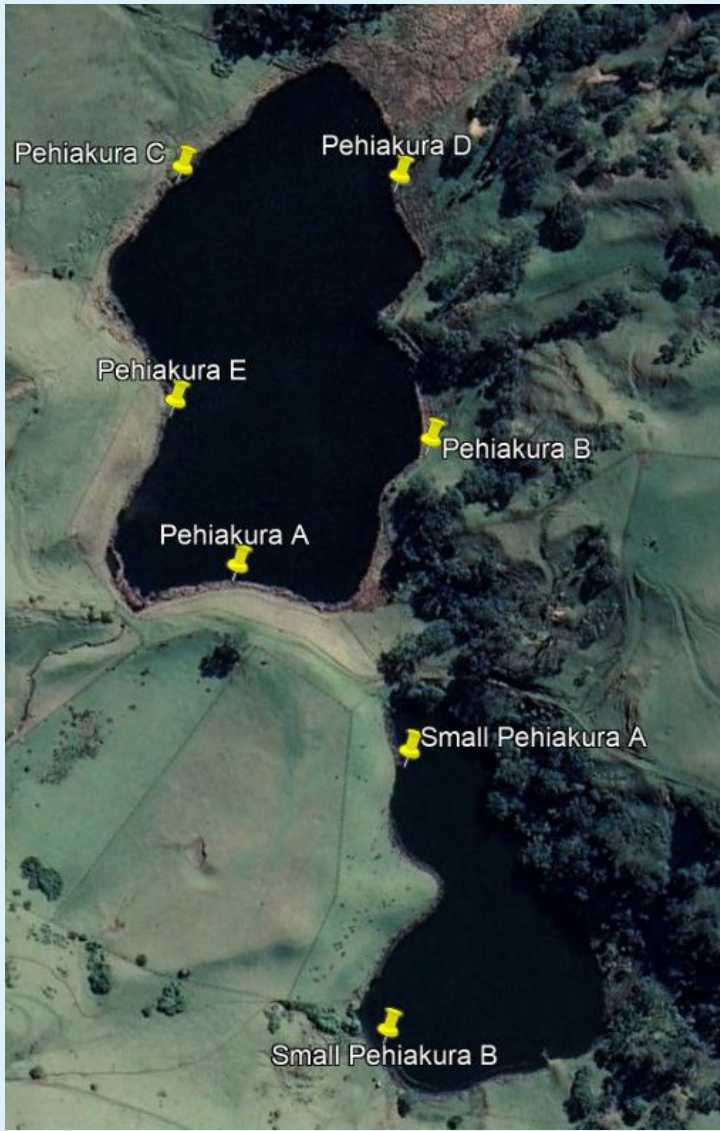
Pehiakura Big A	37 11.016	174 36.865
	Pehiakura Big B	37 10.974	174 36.946
	Pehiakura Big C	37 10.883	174 36.842
	Pehiakura Big D	37 10.886	174 36.933
	Pehiakura Big E	37 10.961	174 36.839
	Pehiakura Small A	37 11.078	174 36.937
	Pehiakura Small B	37 11.171	174 36.928
