Harbour and Estuary Ecology State and Trends in Tāmaki Makaurau / Auckland to 2023

State of the Environment Reporting

Technical Report 2025/15

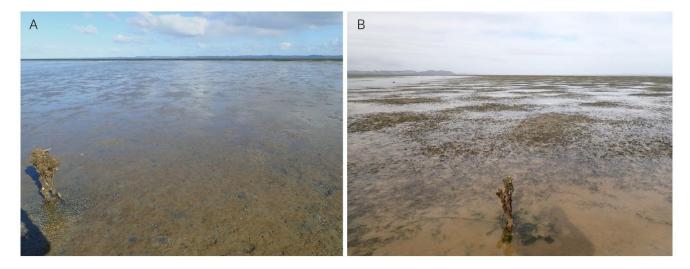
Figure 2. Kakaraia Flats in A) July 2020 (seagrass is visible in the distance) and B) July 2022 (seagrass covers the entire site).

The core monitoring sites in Kaipara Harbour are Kakaraia Flats, Ngapuke Creek, Kaipara Bank and Te Ngaio Point. Haratahi Creek and Kaipara Flats are rotational sites and were last sampled in 2021. There was significant encroachment and colonisation of Kakaraia Flats and Te Ngaio Point by the seagrass *Zostera muelleri* in the years since the previous state and trends report (Figure 2 and Figure 3).

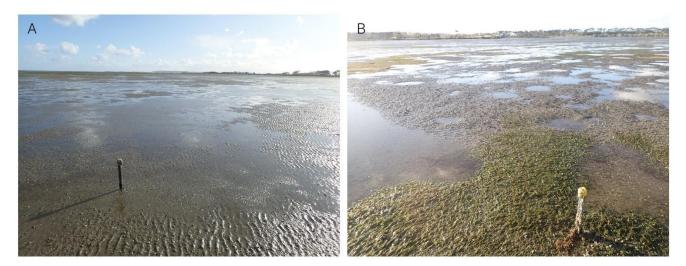
Figure 3. Te Ngaio Point in A) July 2020 (small patches of seagrass occurred at the edge of the site) and B) April 2023 (patches of seagrass cover the entire site).

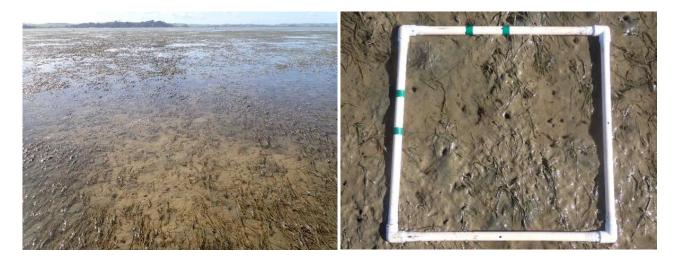
Figure 5. Sediment deposition at Kakaraia Flats in April 2023 (roughly two months after the Auckland Anniversary and Cyclone Gabrielle extreme weather events).

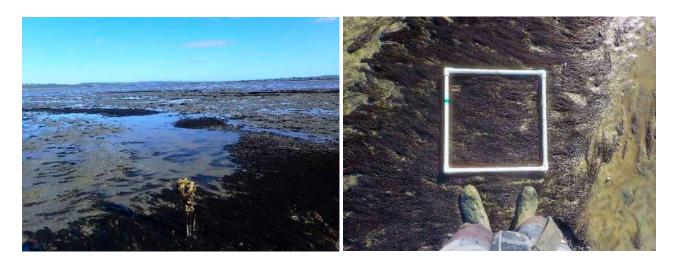
Figure 6. Large blooms of the red seaweed, Gracilaria chilensis, at Kaipara Bank in October 2022.

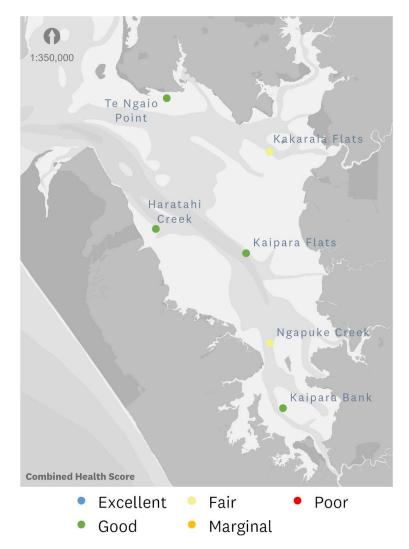
Figure 7. Combined Health Scores for Kaipara Harbour monitoring sites in 2021 (rotational sites) and 2023 (core sites).

Overall health according to the Combined Health Score was mostly 'Good', although two sites had 'Fair' health; Ngapuke Creek which is in the southern compartment of the harbour and Kakaraia Flats which is downstream of Hōteo River (Figure 7). The Kakaraia Flats site is now completely covered by seagrass and Benthic Health Models (BHMs) are unlikely to accurately assess health in such habitats. This may be the cause of the comparatively low Combined Health Score at Kakaraia Flats and as such, BHM state and trends are not presented or discussed any further for this site.

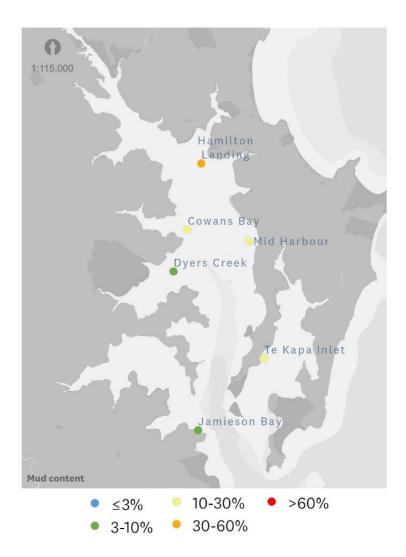
Figure 15. Sediment mud content at Mahurangi Harbour monitoring sites in 2022 (rotational sites) and 2023 (core sites).

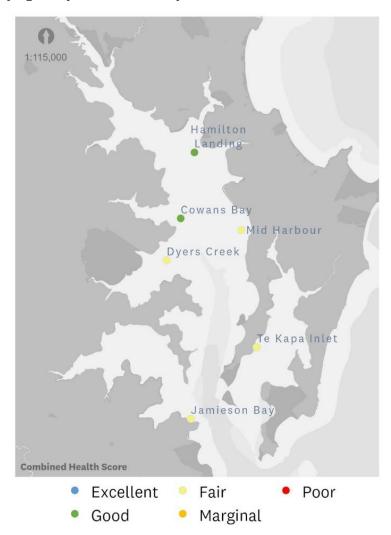
Figure 17. Combined Health Scores for Mahurangi Harbour monitoring sites in 2022 (rotational sites) and 2023 (core sites).

Overall health according to the Combined Health Score was mostly 'Fair', although two sites had 'Good' health; Hamilton Landing and Cowans Bay. This is counterintuitive as environmental conditions at these sites were poor (sediment mud content was high and organic content was elevated), and health in relation to mud and metals was 'Marginal' (Table 13). The method for calculating the Combined Health Score requires that when a site is allocated to the 'Marginal' or 'Poor' BHMmetals group, the Combined Health Score is equivalent to the TBI. Both Hamilton Landing and Cowans Bay had 'High' TBI scores despite their otherwise unhealthy state. This phenomenon highlights the importance of considering the individual indices contributing to the Combined Health Score rather than relying solely on this summary metric.

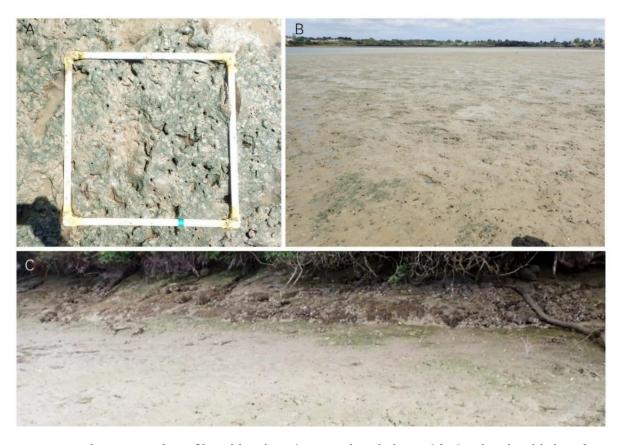
Figure 21. Conspicuous patches of benthic microalgae at A) and B) Herald Island Waiarohia in February 2021 and C) Lucas Creek in May 2022.

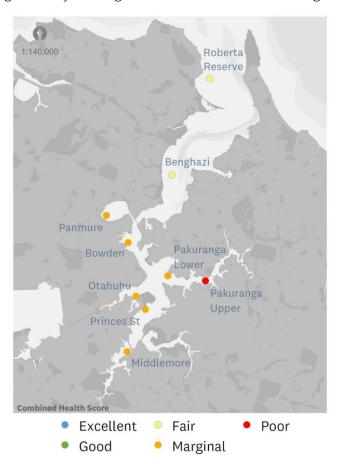
Figure 30. Combined Health Scores for Tāmaki Estuary sites between 2017 and 2022.

Between 2017 and 2022, overall health according to the Combined Health Score ranged from 'Fair' to 'Poor' and was most commonly 'Marginal' (Figure 30). Sites with the poorest health tended to be in the upper reaches of the estuary and health improved towards the estuary mouth, largely mirroring the pattern in sediment mud content. Functional resilience (according to the TBI) ranged from 'High' to 'Low' and increased significantly at Benghazi and Ōtāhuhu over the long-term (Table 24).
